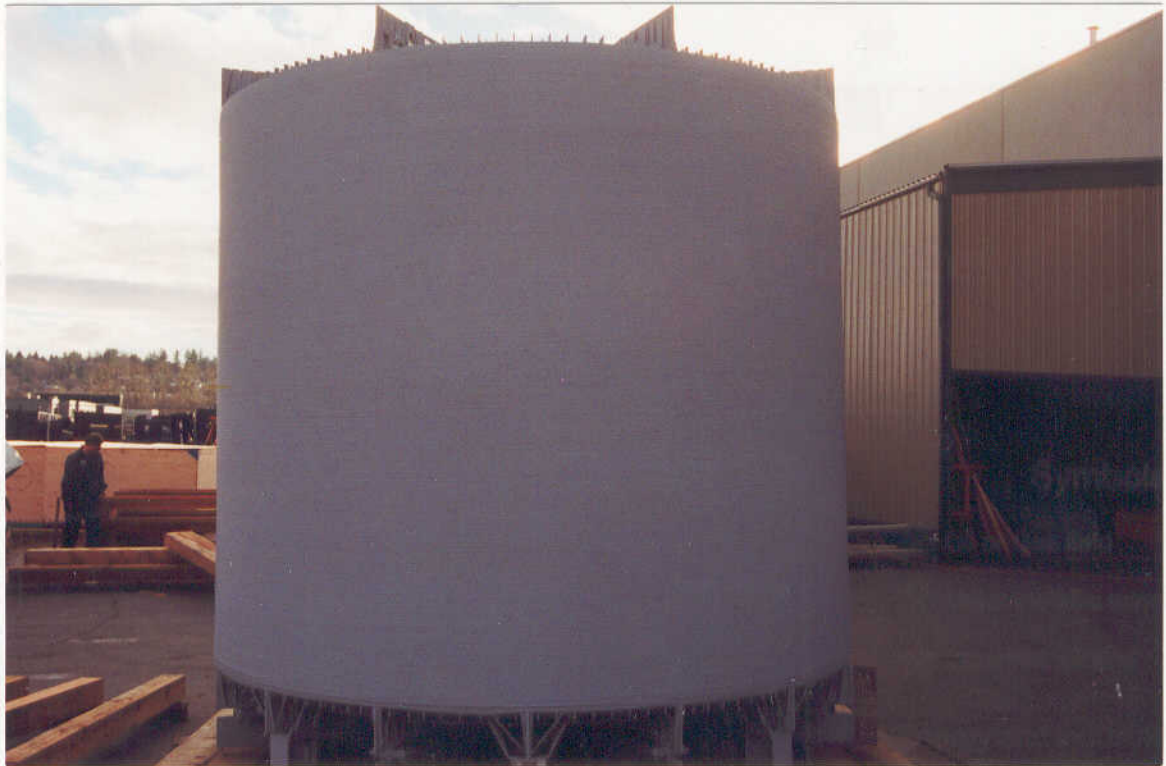
No. 1 - The camera was facing approximately south. View of the side of the Reactor, which was facing north, while at the premises of Cratex Industrial Packing Ltd. in Coquitlam (near Vancouver), BC.

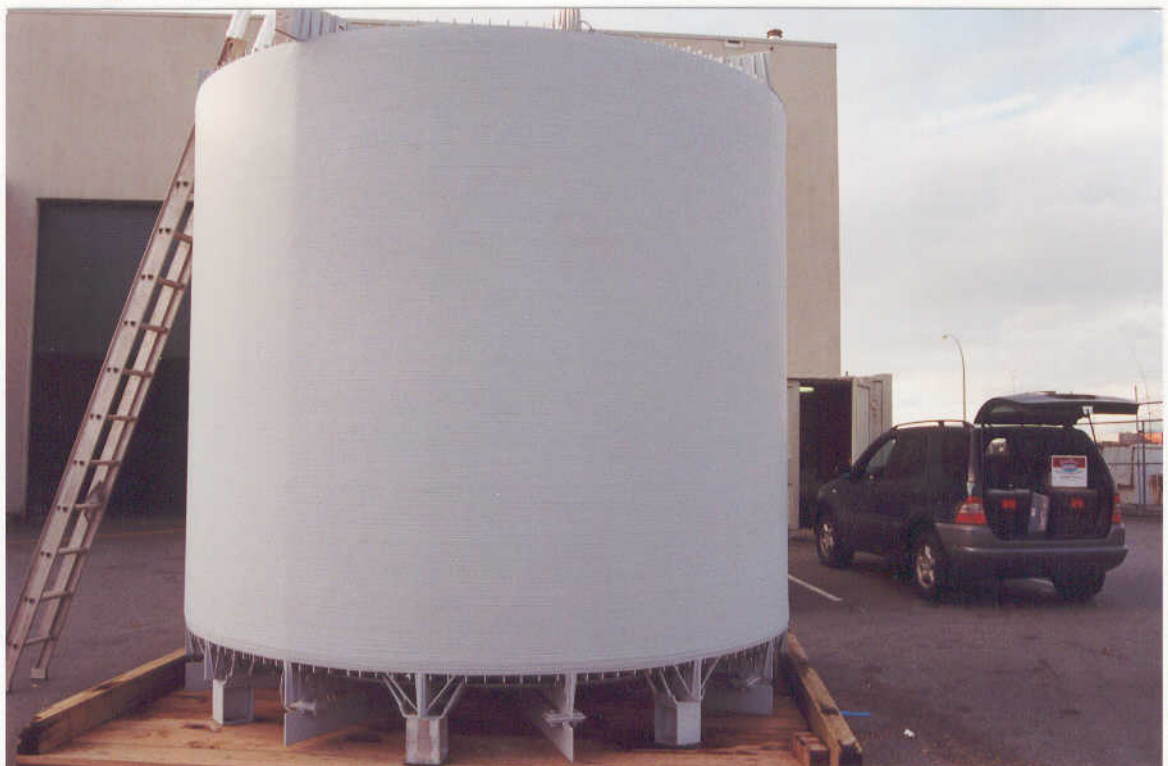
No. 2 - The same as above, but the camera was facing approximately west. This side of the Reactor was facing east.

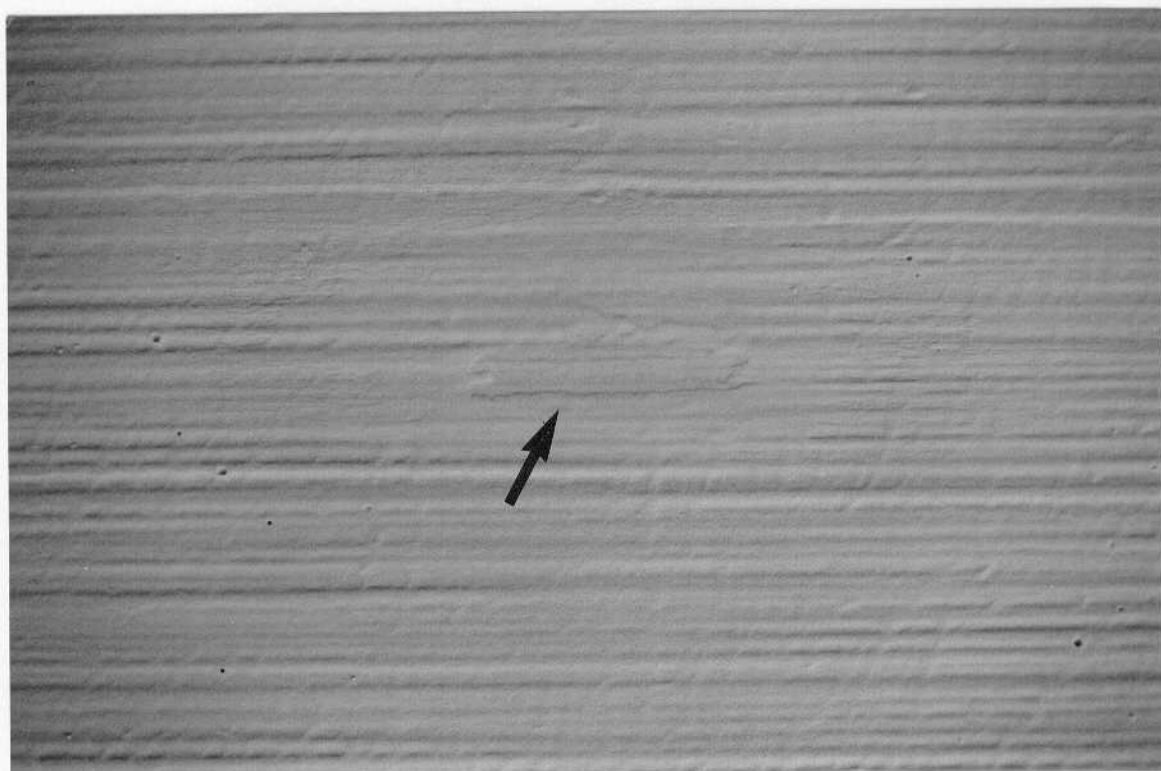
No. 3 - Close-up showing the repaired scratch on the side of the Reactor which was facing east. This scratch can be seen in one of the Photographs of Mr. Roger Robinson, CMS, before it was repaired (APPENDIX "A").

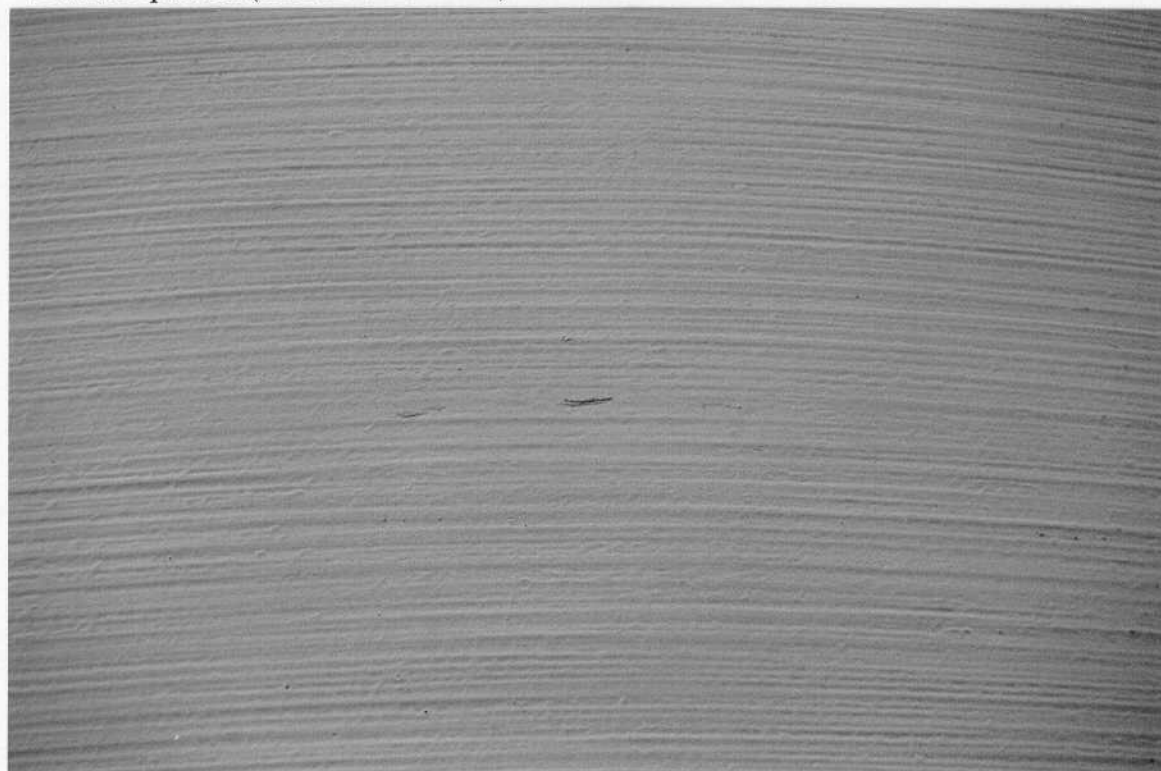
No. 4 - Minor unrepaired scratch found on the side which was facing east, above the above described repaired scratch.

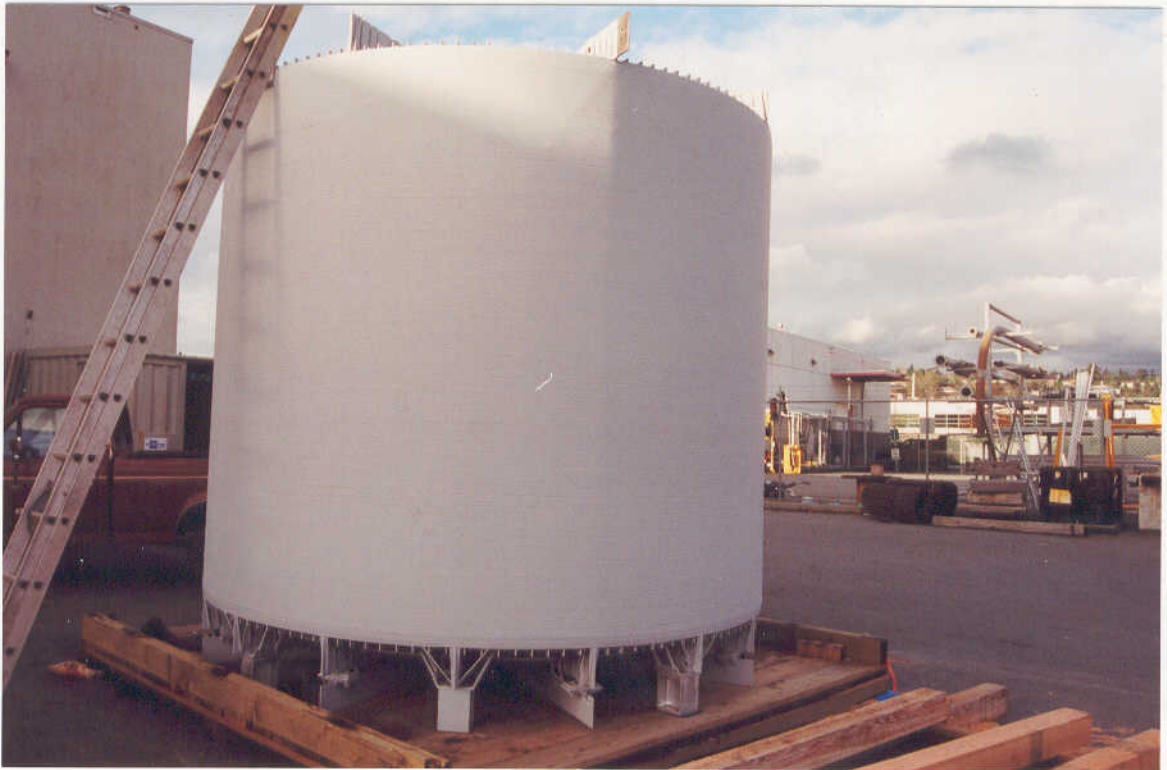
No. 5 - Another view of the Reactor while the Camera was facing approximately northwest. This was the side of the Reactor which was facing southeast.

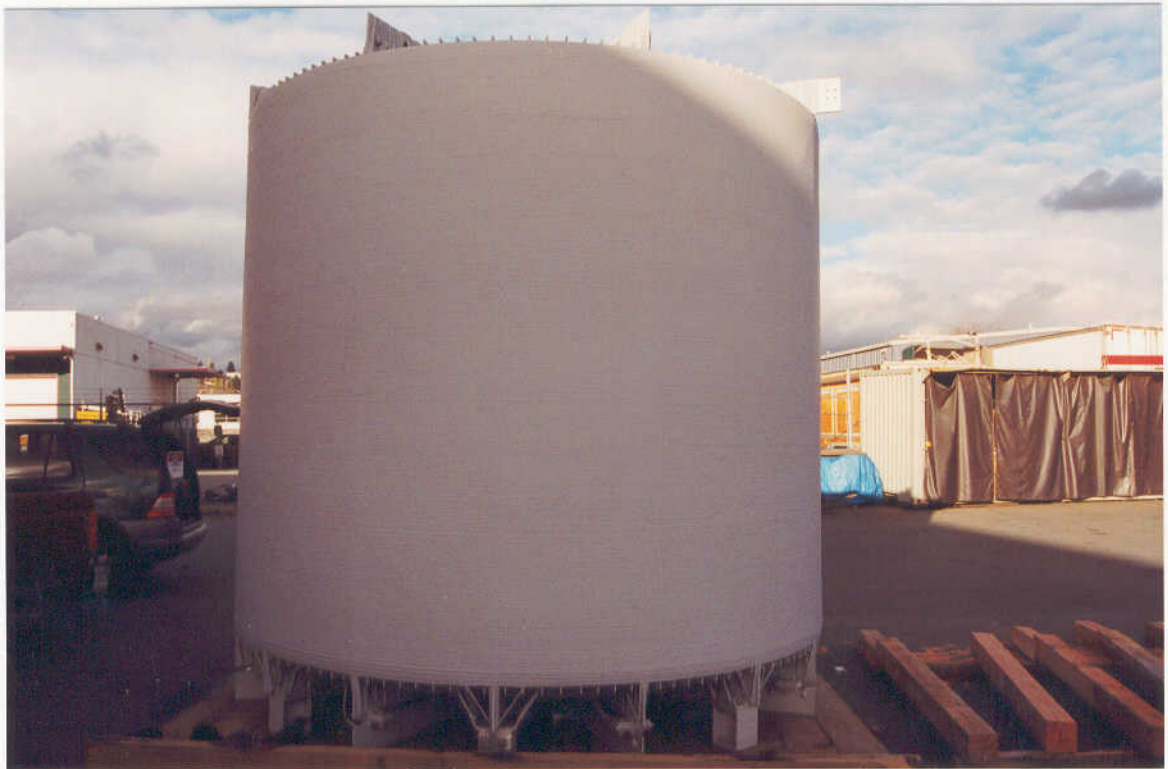
No. 6 - Another view of the Reactor while the Camera was facing approximately north. This was the side of the Reactor which was facing south.
