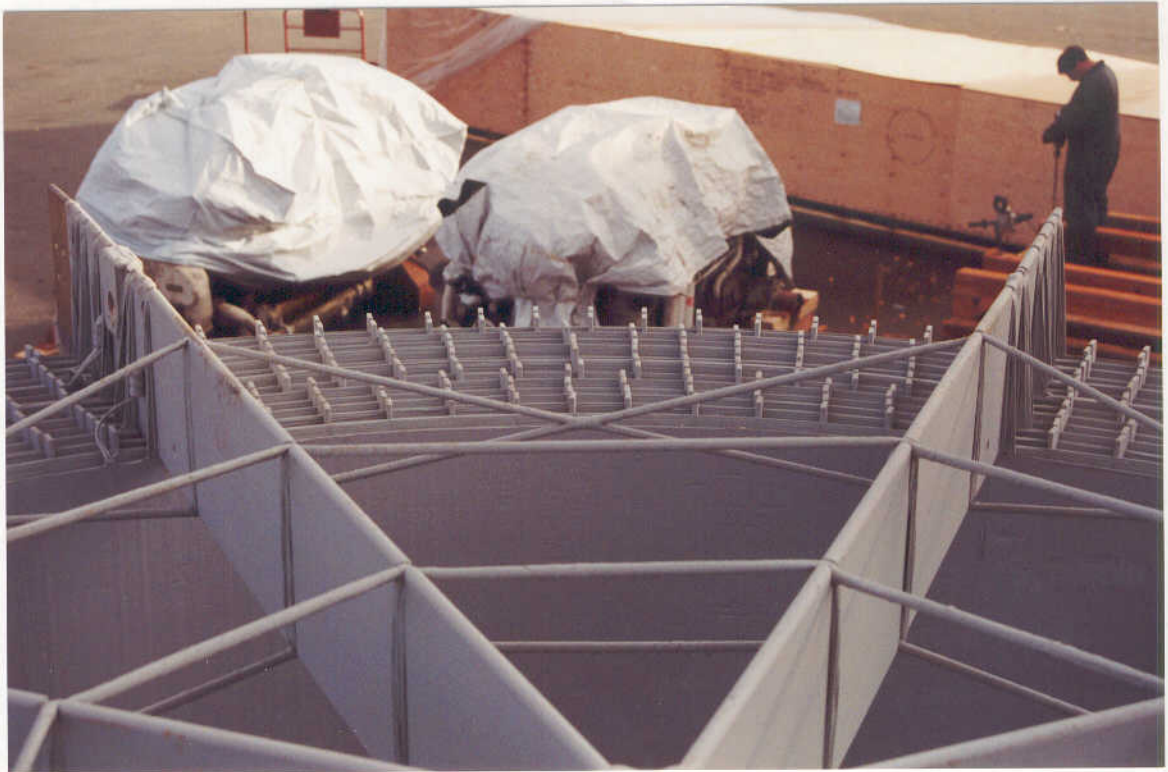
No. 15 - Clockwise (rightward, viewer's right) continuation of the view in Photograph No. 13. No damages were visible on the right (viewer's right) of the scratches.

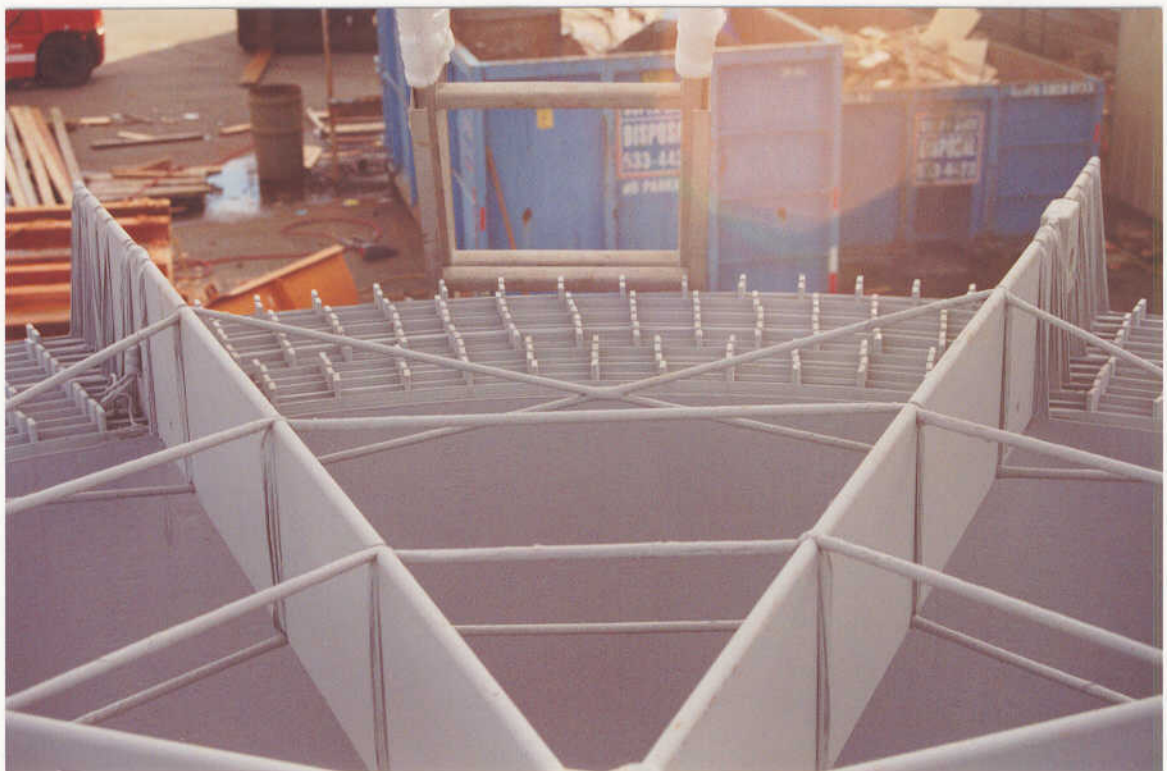
No. 16 - Clockwise (rightward, viewer's right) continuation of the view in the above Photograph. Note evidence of physical damages were visible in this area.

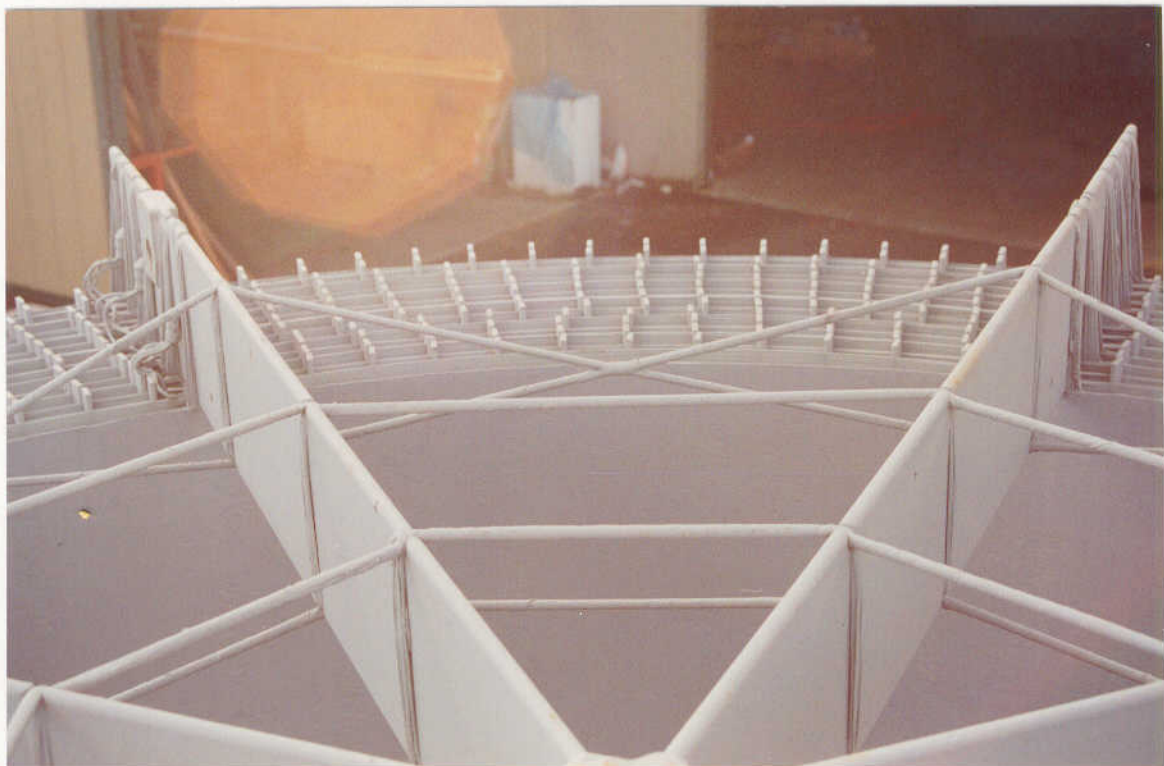
No. 17 - Clockwise (rightward, viewer's right) continuation of the view in the immediate preceding Photograph. Note evidence of physical damages were visible in this area.

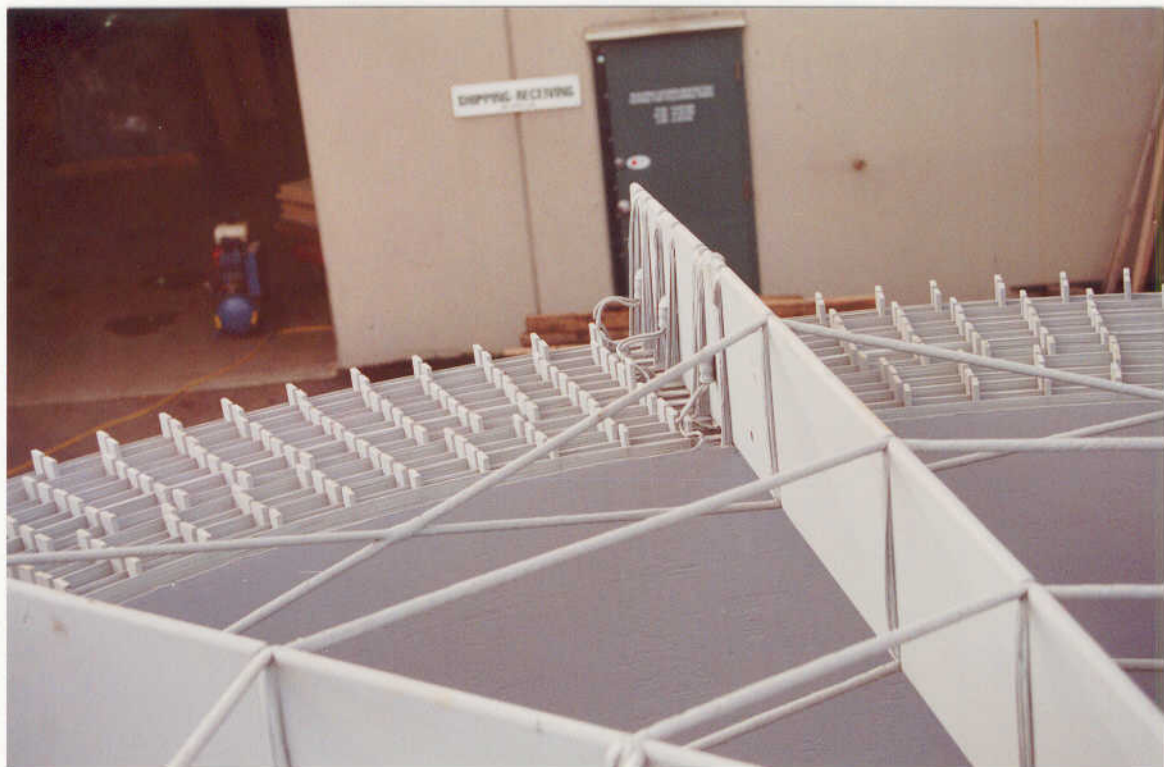
No. 18 - Clockwise (rightward, viewer's right) continuation of the view in the above Photograph. Note evidence of physical damages were visible in this area.
