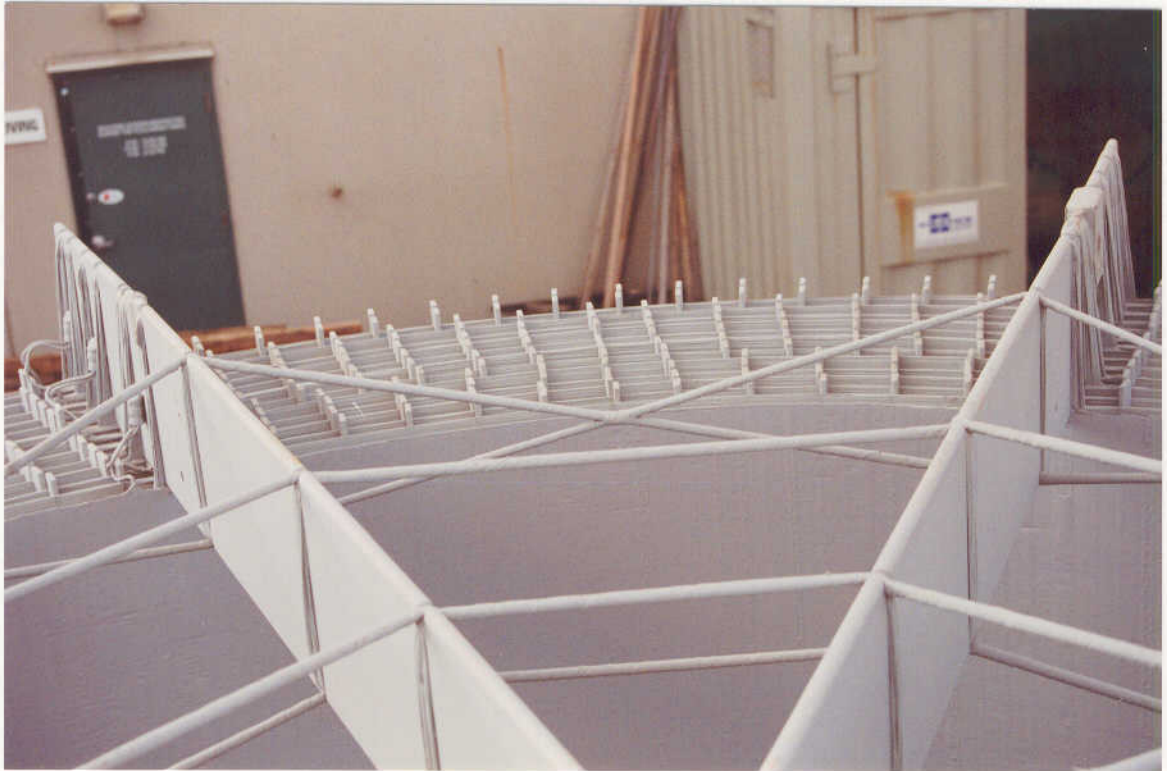
No. 19 - Clockwise (rightward direction, viewer's right) continuation of the view in the immediate preceding Photograph. Note evidence of physical damages were visible in this area.

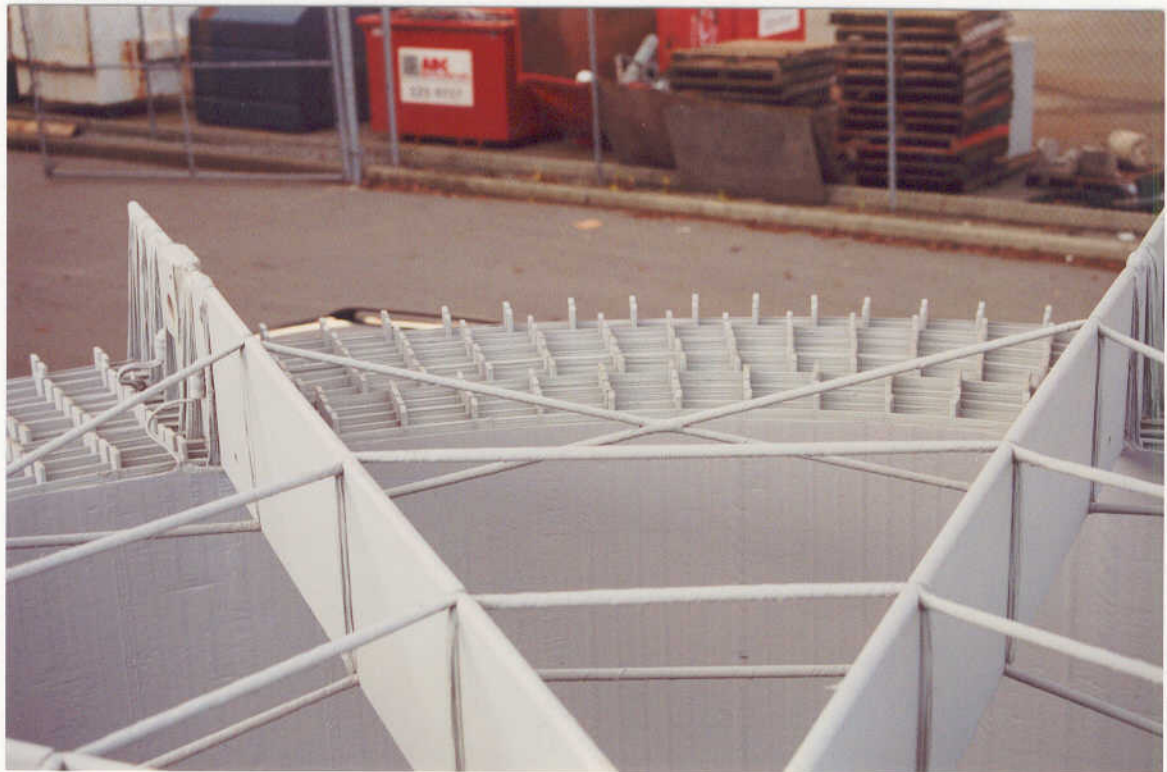
No. 20 - Clockwise (rightward, viewer's right) continuation of the view in the above Photograph. Note evidence of physical damages were visible in this area.

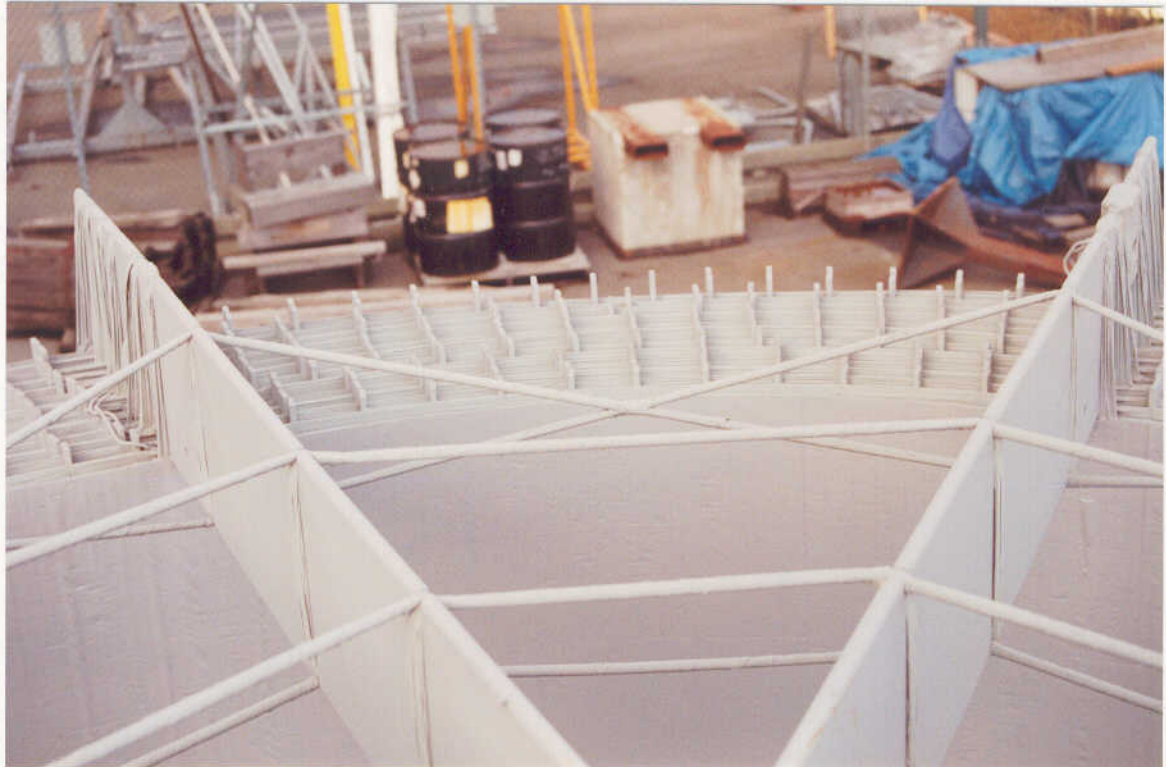
No. 21 - Clockwise (rightward direction, viewer's right) continuation of the view in the immediate preceding Photograph. Note evidence of physical damages were visible in this area.

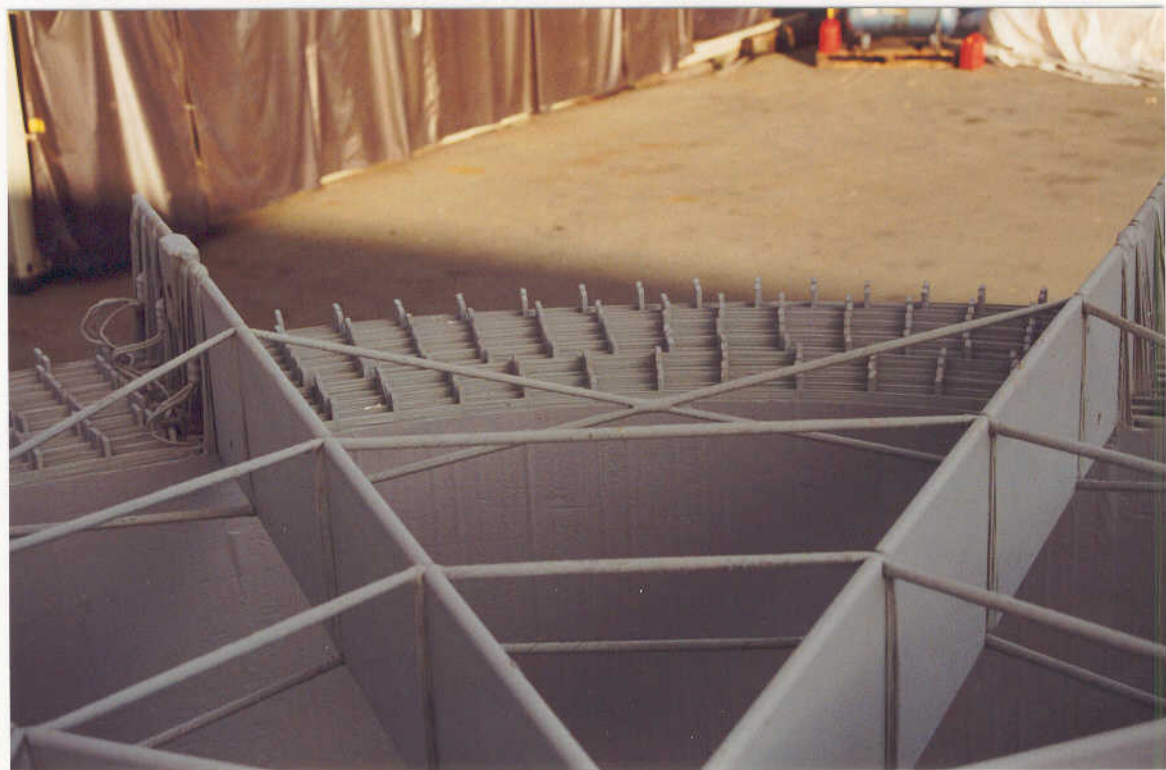
No. 22 - Clockwise (rightward, viewer's right) continuation of the view in the above Photograph. Note evidence of physical damages were visible in this area.
